Grain / Port

Millwright / Industrial Service

**PROJECT:**

# INDUSTRIAL GRAIN SPOUT REPAIR

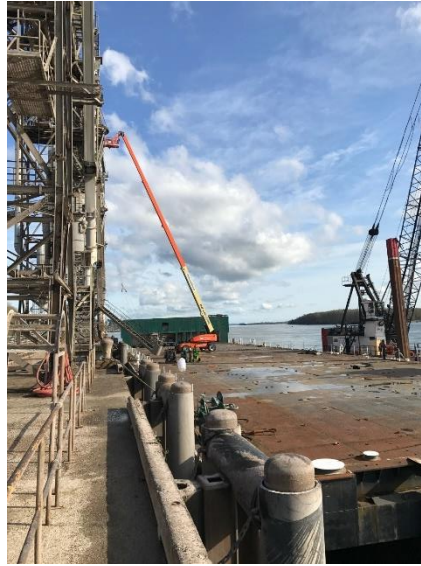
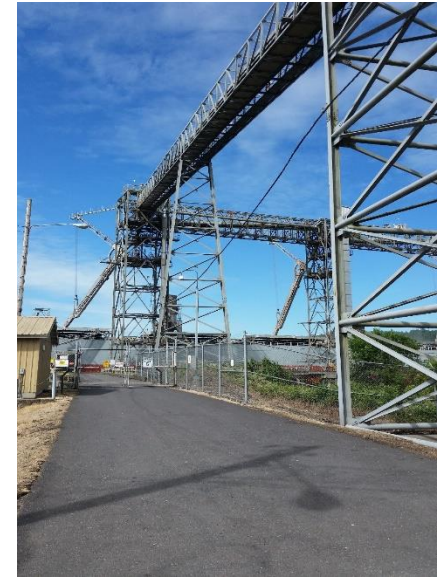
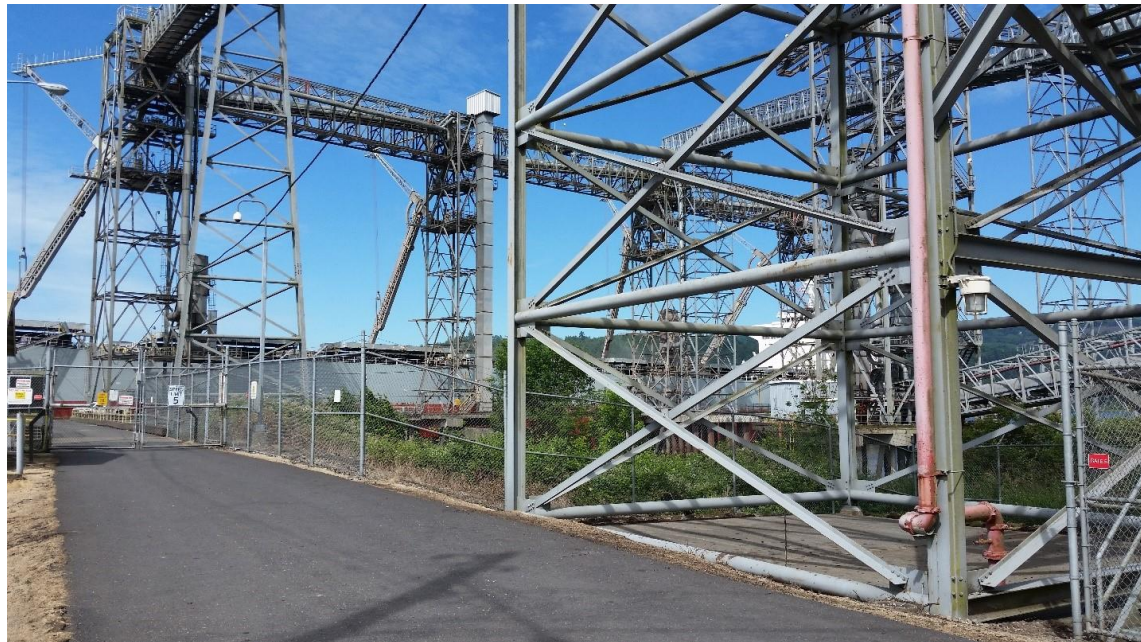
Omega Morgan's Millwright team was called in to assess and correct the issues that were going on with the Spout #3. After determining that the issues were being caused by the main support pivot pin responsible for steering and supporting the spout was fractured, our Millwright team arranged a crew, ocean-going barge, tug service, scaffolding services and derrick barge crane to replace the faulty pivot pin.

- Ocean-going Barge
- Tug Boats
- Scaffolding
- Derrick Barge Crane
- 150' Manlift
